Monticello Vicinity Property Project
Site Assessment Report for
Sutherland Brothers, Inc., Property
(MP-00990-CS)

July 1995

Prepared by
Rust Geotech
Grand Junction, Colorado

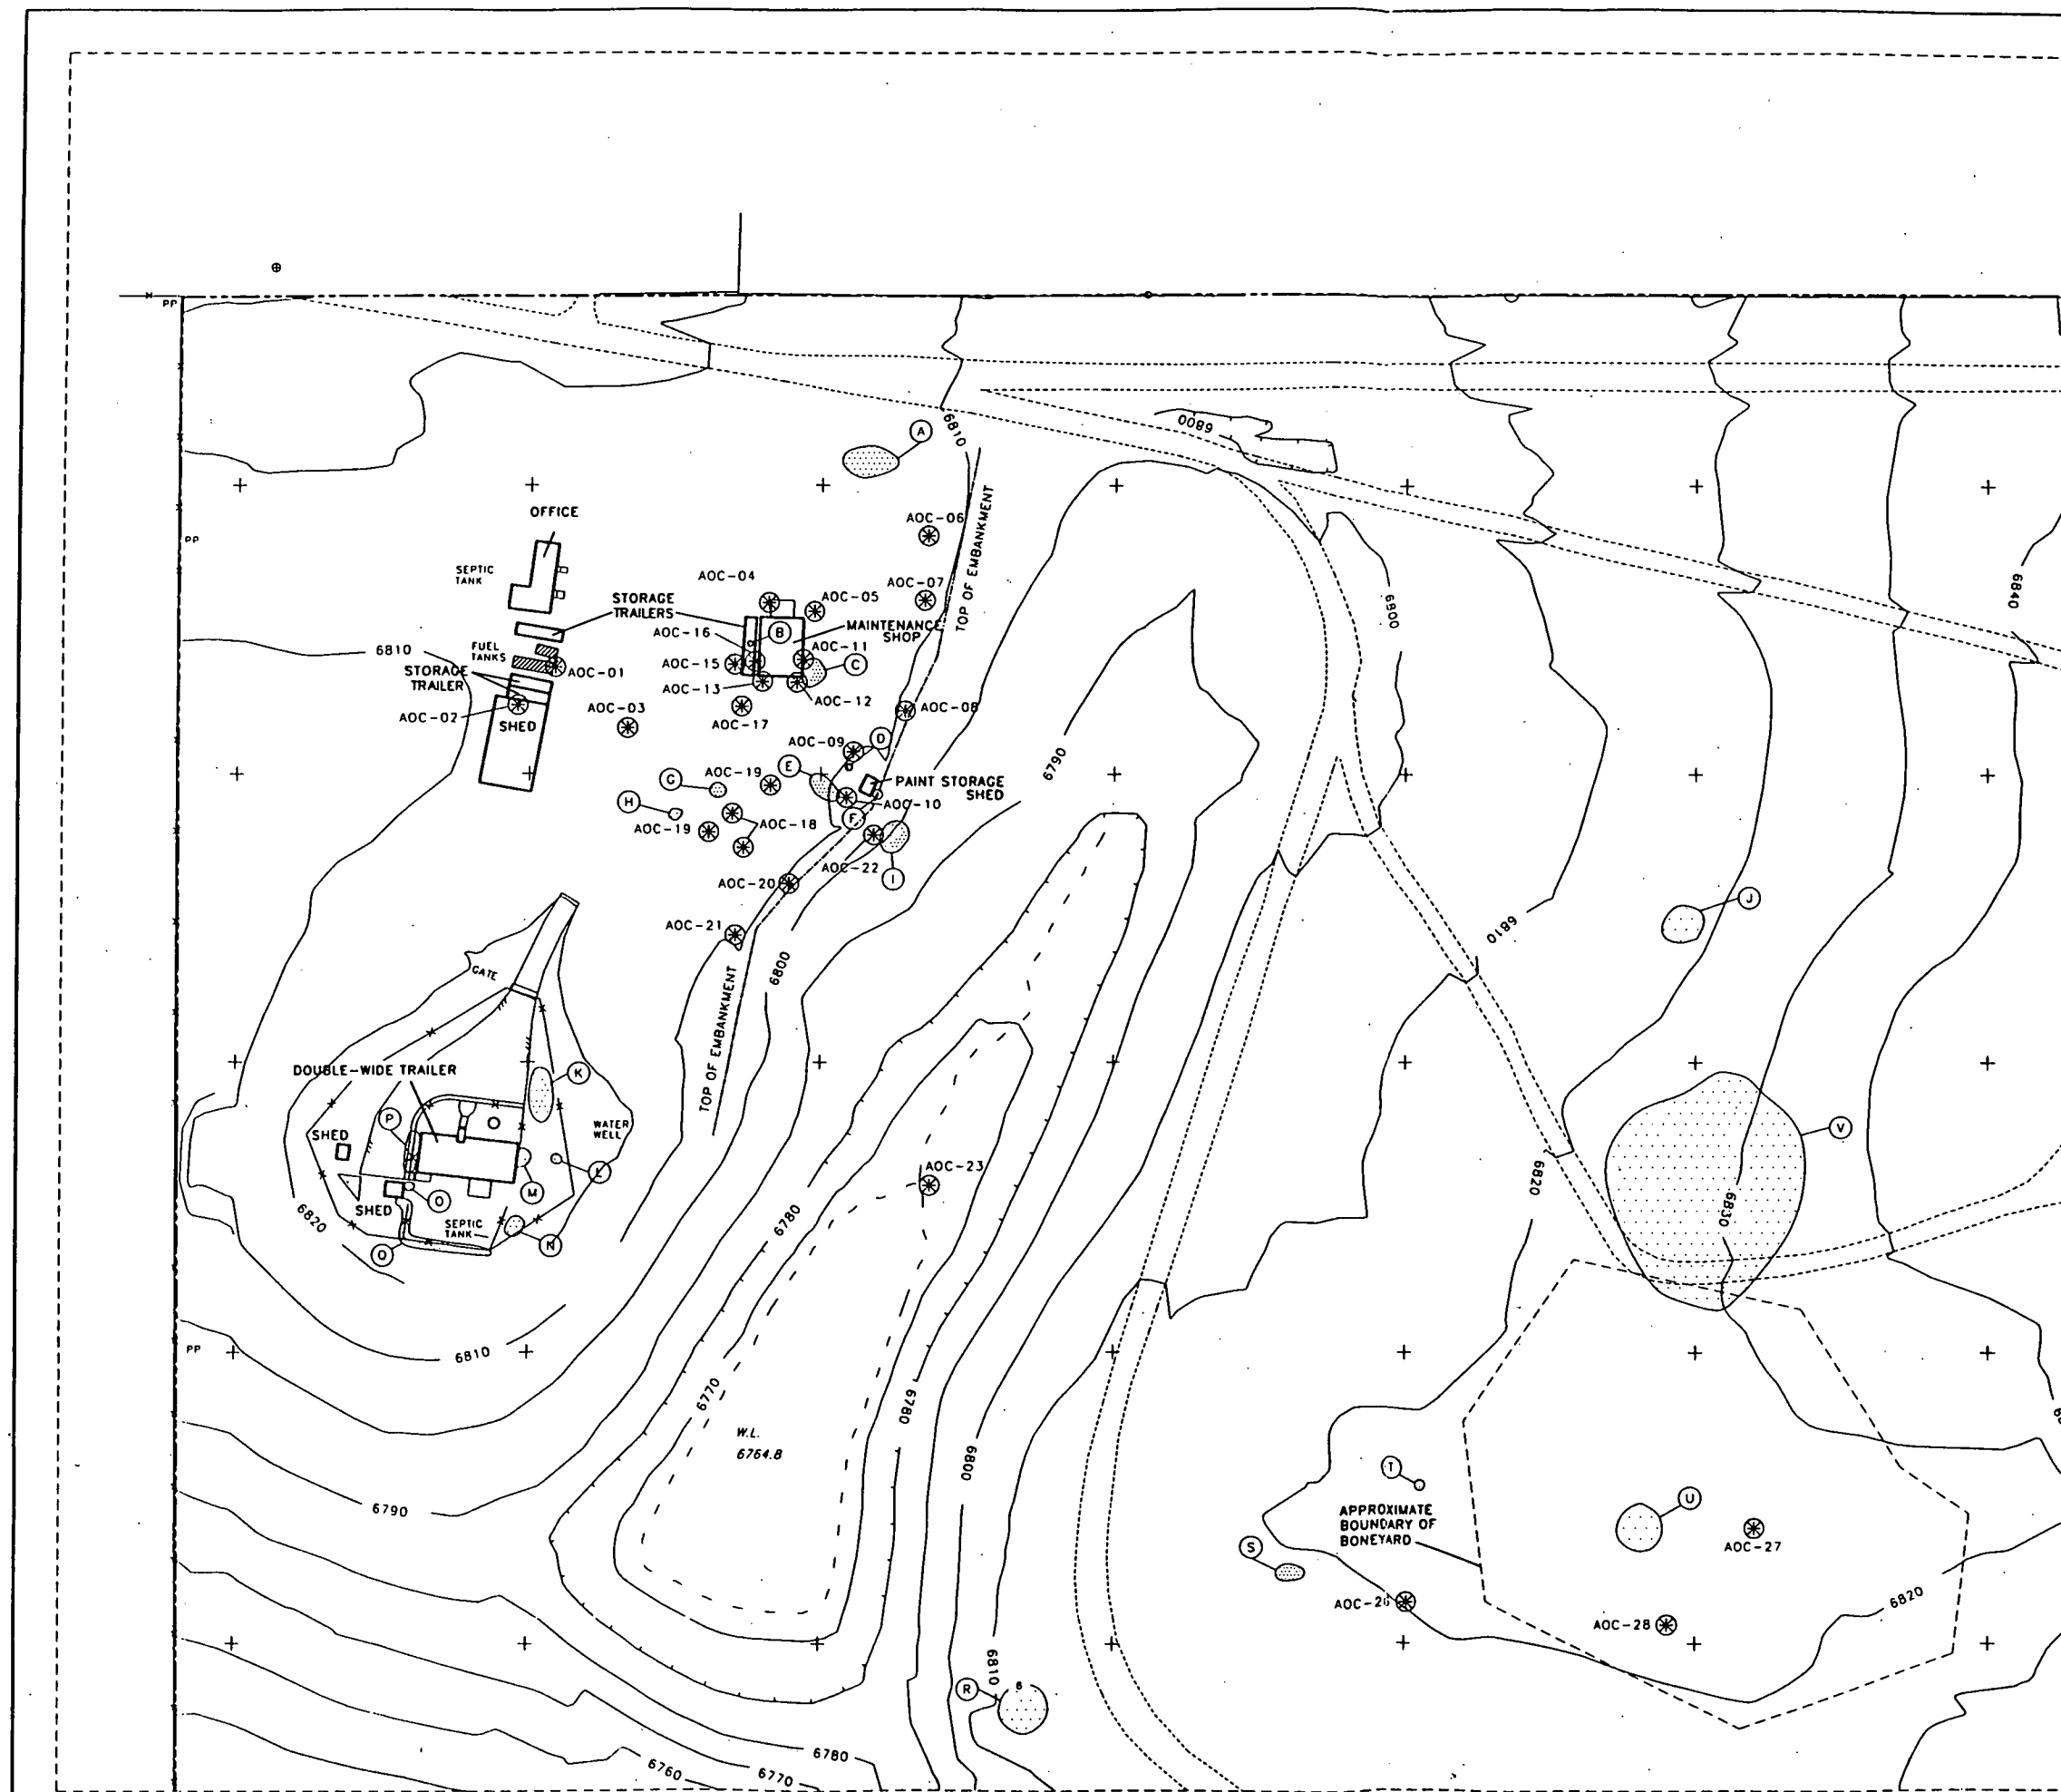
FIGURE 3a
LOCATIONS OF AREAS OF CONCERN

The approximate 200-square-foot area of stained soil surrounding the above-ground petroleum tanks shows indications of spilling from fueling vehicles and equipment. Based on evidence of a release of potential hazardous substances to the environment, this area is considered an area of concern, and is identified as AOC-01 on Figure 3a.
